DEPARTMENT OF TRANSPORTATION

Contract #: 04-0120F4Cty: SF/ALA Rte: 80 PM: 13.2/13.9File #: 69.28**WELDING INSPECTION REPORT****Resident Engineer:**Pursell, Gary**Address:** 333 Burma Road**City:** Oakland, CA 94607**Report No:** WIR-015615**Date Inspected:** 14-Jul-2010**Project Name:** SAS Superstructure**OSM Arrival Time:** 700**Prime Contractor:** American Bridge/Fluor Enterprises, a JV**OSM Departure Time:** 1900**Contractor:** Zhenhua Port Machinery Company, Ltd (ZPMC), Changxing Island **Location:** Shanghai, China**CWI Name:** Li Yang**CWI Present:** Yes No**Inspected CWI report:** Yes No N/A**Rod Oven in Use:** Yes No N/A**Electrode to specification:** Yes No N/A**Weld Procedures Followed:** Yes No N/A**Qualified Welders:** Yes No N/A**Verified Joint Fit-up:** Yes No N/A**Approved Drawings:** Yes No N/A**Approved WPS:** Yes No N/A**Delayed / Cancelled:** Yes No N/A**Bridge No:** 34-0006**Component:** OBG Segment**Summary of Items Observed:**

WELDING INSPECTION REPORT

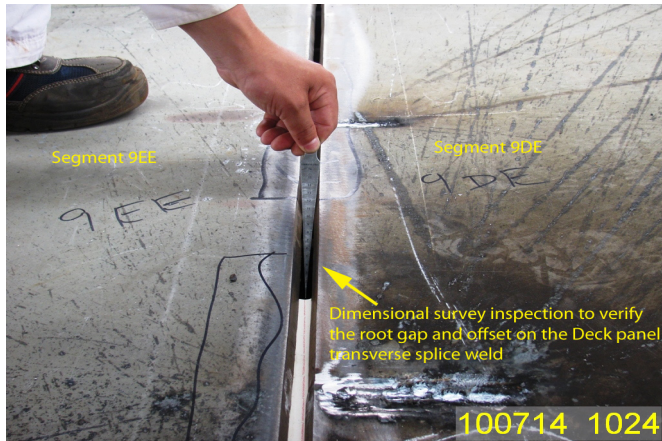
This QA Inspector along with QA inspector Mr. Manjunath S Math performed the dimensional survey inspection to verify the root gap and offset on the transverse splice weld of segment 9DE and segment 9EE. The measurements were recorded on a separate sheet and forwarded to team leader for review and disposition. The segment and panel point designations were as follows:

Segment 9DE to Segment 9EE – PP 82 to PP 83.
